PHASE I INSPECTION REPORT  
NATIONAL DAM SAFETY PROGRAM

**COTTONWOOD DAM  
WILSALL, MONTANA  
PARK COUNTY  
MT 21**

HKM ASSOCIATES  
BILLINGS, MONTANA

FEBRUARY 1981

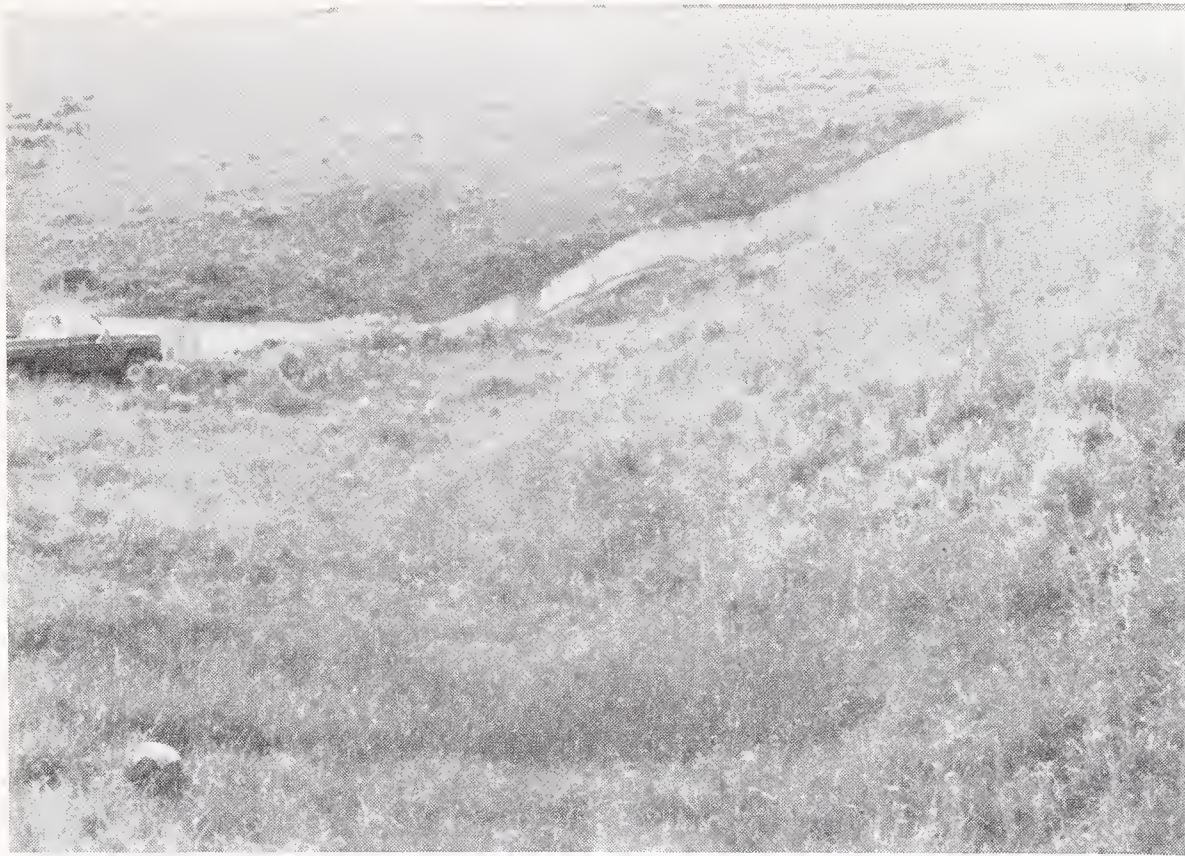
Photo No. 6 - Dam Crest

Accumulations of precipitation on the dam crest in the traffic path, combined with the vehicular traffic, has caused some ponding and created small erosion gullies (Photo 6 of Appendix B). A rather large depression has developed where the road (traffic) ascends the downstream slope of the dike.

The dam crest is shown looking from north to south.

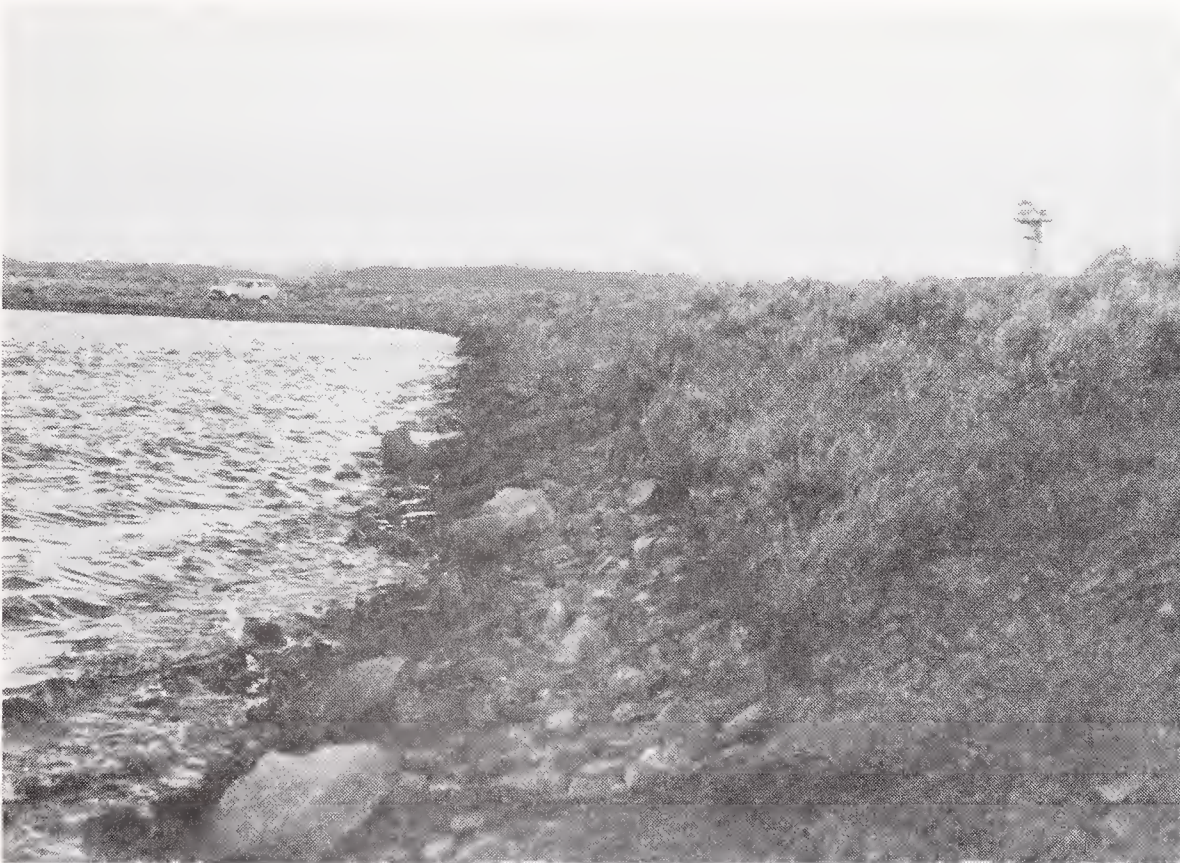
The downstream face of the dam and dike has a slope of 1V on 2H. There is a moderate cover of natural grasses, weeds, and sagebrush on the downstream slope (Photo 7 of Appendix B).

Photo No. 7 - Downstream Dam Embankment  
The downstream side of the embankment  
is shown looking towards the south.

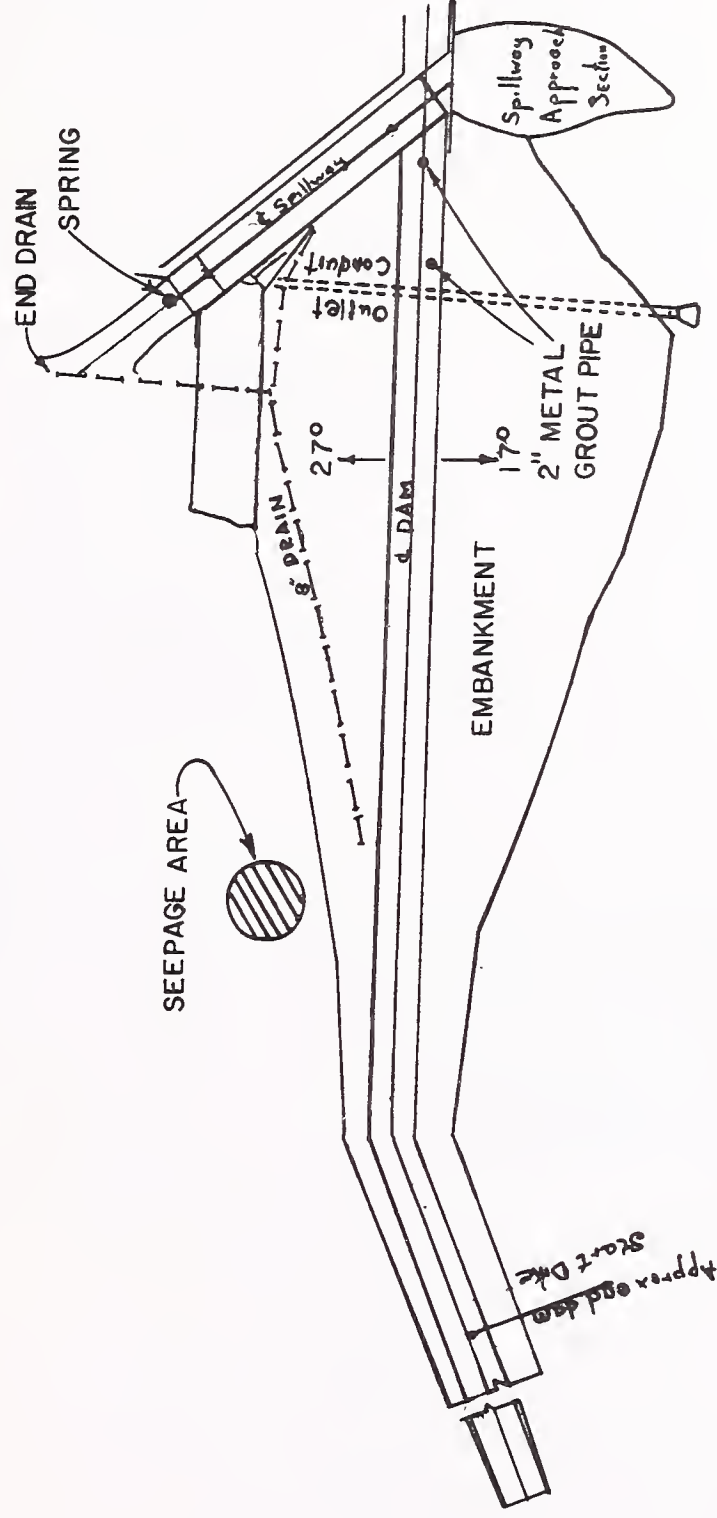
EXHIBIT C3

At the time of the June 1980 field investigation, Cottonwood Reservoir was at the normal pool level (elevation 82.50 feet). Three general seepage areas were identified during this investigation; at the left abutment just below the downstream toe, downstream from the main embankment, and near the spillway stilling basin. The small seepage area on the left abutment (Photo 7 of Appendix B) is identified by saturated soil and lush water-type grasses. Free water was not evident at the time of this investigation. This area, as identified on Exhibit C3, appears to be located just beyond the end of the drain pipe.
